# INADEQUATE CASES OF INTERVENTION IN ARCHITECTURAL HERITAGE BUILDINGS IN MEXICO AFTER THE SEPTEMBER 2017 EARTHQUAKES

FERNANDO PEÑA<sup>1\*</sup> AND MARCOS M. CHÁVEZ<sup>1</sup>

<sup>1</sup>Instituto de Ingeniería  
Universidad Nacional Autónoma de México  
Ciudad Universitaria, 04510 Mexico City, Mexico  
e-mail: [fpem@pumas.iingen.unam.mx](mailto:fpem@pumas.iingen.unam.mx), [mchavezc@iingen.unam.mx](mailto:mchavezc@iingen.unam.mx), [www.iingen.unam.mx](http://www.iingen.unam.mx)

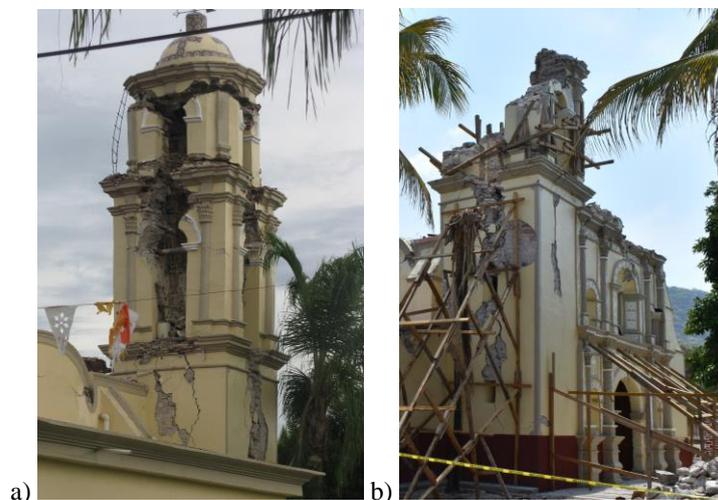
One of the first activities in a structure damaged by an earthquake is to carry out emergency works, to avoid collapse of the damaged areas. The objective of emergency works are to improve the stability conditions of the damaged structure, to resist, not only the own weight of the structure, but also accidental loads that may occur before or during the restoration works, such as the aftershocks [3-6]. For example, figure 1a shows the damage tower of the temple of Pilcaya, Puebla after the earthquake. It can be observed that although the tower had severe damage, it did not collapse. Few days later, before the emergency works began, the tower collapsed, standing only part of the first body of the tower (figure 1b). It seems that the cause of the collapse was the vibration inducing by passing trucks and vehicles on the streets adjacent to the temple.

**Figure 1:** Damaged tower of temple of Pilcaya, Puebla: a) after earthquake; b) few days after the seismic event

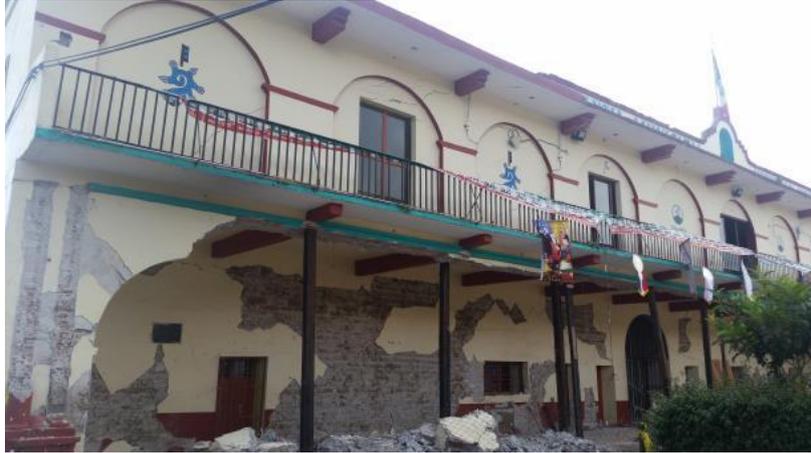
Figure 2 shows the Municipal Palace of Hueyapan, Morelos after the earthquake. The building was made with unreinforced brick masonry. The loss of the lower archway is observed, which puts the stability of the balcony at risk. In the upper part, diagonal shear cracks are observed. It is noted that the balcony shoring system is not adequate, as the struts will not be able to withstand lateral forces in case of an aftershock. In this particular case, the shoring system was thought only for vertical forces.

**Figure 2:** Municipal Palace of Hueyapan, Morelos

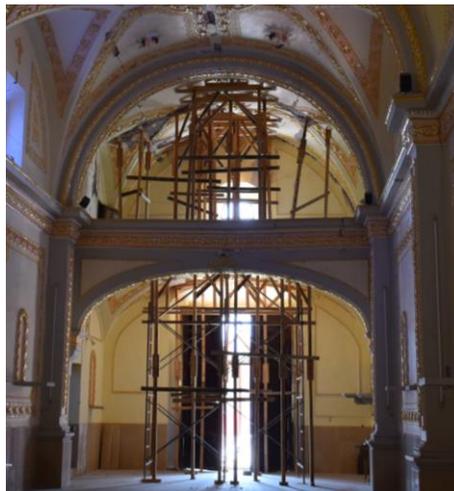
When the building has two or more levels and the damage are located in superior levels, it is necessary to ensure that the transmission of shoring system loads from the upper levels to the foundation is carried out properly. This is particularly important when the shoring of the upper levels rests directly on the slab, arches or beams of the lower level. In order to avoid overloading and damage of the supporting structural elements, a shoring must be placed in the lower levels in order to have a correct transmission of the loads. For example, figure 3 shows an example where a shoring in the ground floor was set in order to take the loads of the upper shore.

**Figure 3:** Example of a correct transmission of shoring system loads of higher than lower levels

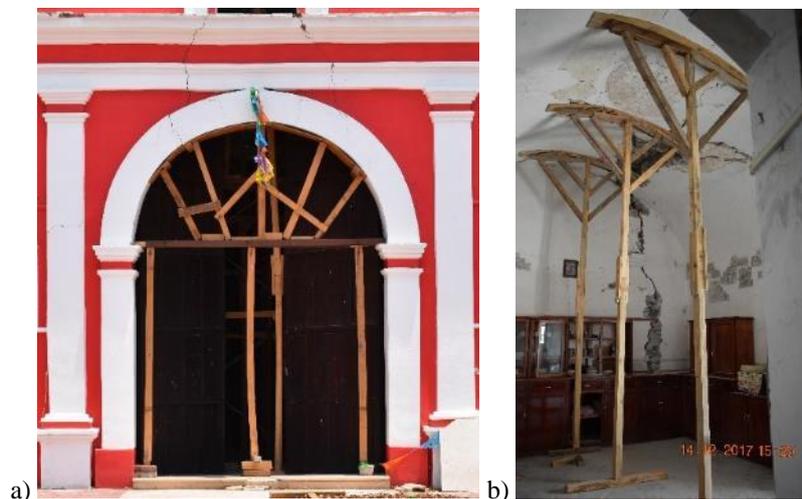
**Figure 5:** Example of bad quality wooden elements: a) buckled element; b) slender elements

Figure 5 shows two example of a bad quality of wooden systems. In figure 5a, it can see that one of the vertical element is buckling, reducing its structural capacity. Additionally, vertical elements are not high enough, so brick pieces were used at the base, to increase their height.

Figure 5b shows an example of a scarce shoring system, where slender elements are used. It is clear that this system is unable to take lateral and vertical forces.

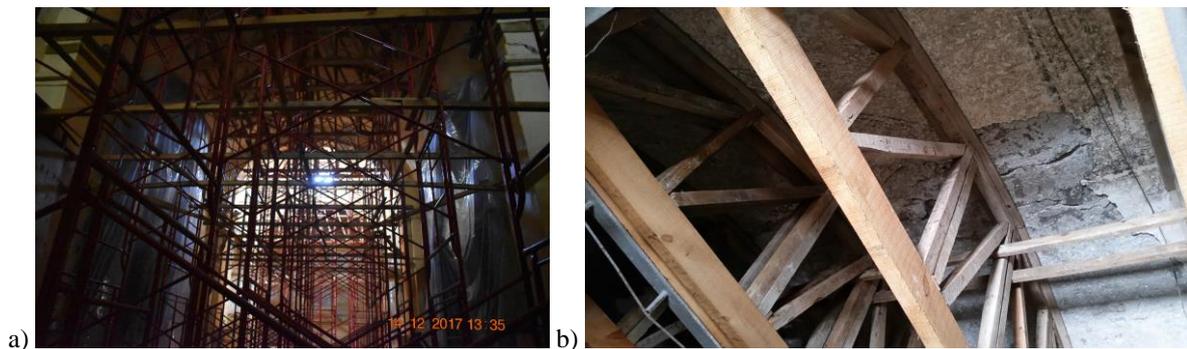
Due to the lack of experience and non-engineering criteria, there are cases in which there is a waste of economic and material resources, as well as workmanship, which can be used in other damage buildings. For example, there are cases with an excessive shoring, preventing people from entering the building. In these cases, part of the scaffolding must be dismantled before an intervention process, in order to have space to start the intervention works. There are also cases, in which the shoring is placed directly over a crack, so it will be necessary to remove it in case of an intervention (fig. 6). For this reason, it is important to make a preliminary structural analysis to determine the characteristics of the shoring system and as far as possible, place it so that it does not interfere with the intervention works.

**Figure 6:** Example of bad criteria of emergency works: a) excessive shoring; b) shoring over a crack

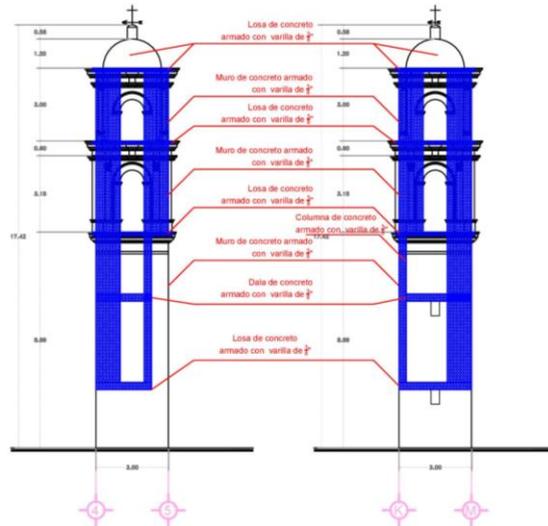
For example, some proposals to rebuild the belfry and to strengthen the bell tower of the church shown in figure 1. One of the proposals consisted to rebuild the belfry with reinforced concrete and strength the body of the tower with reinforced concrete walls (fig. 7). But this solution is invasive and irreversible; as well as, change the structural authenticity. In addition, there is incompatibility between the new and old elements. It is not clear how the union between the elements of reinforced concrete and the original elements of stone masonry will be made. The concrete walls do not reach the foundation, which will cause a concentration of stresses in the non-reinforced elements.

**Figure 7:** Reinforcement of a bell tower with concrete walls

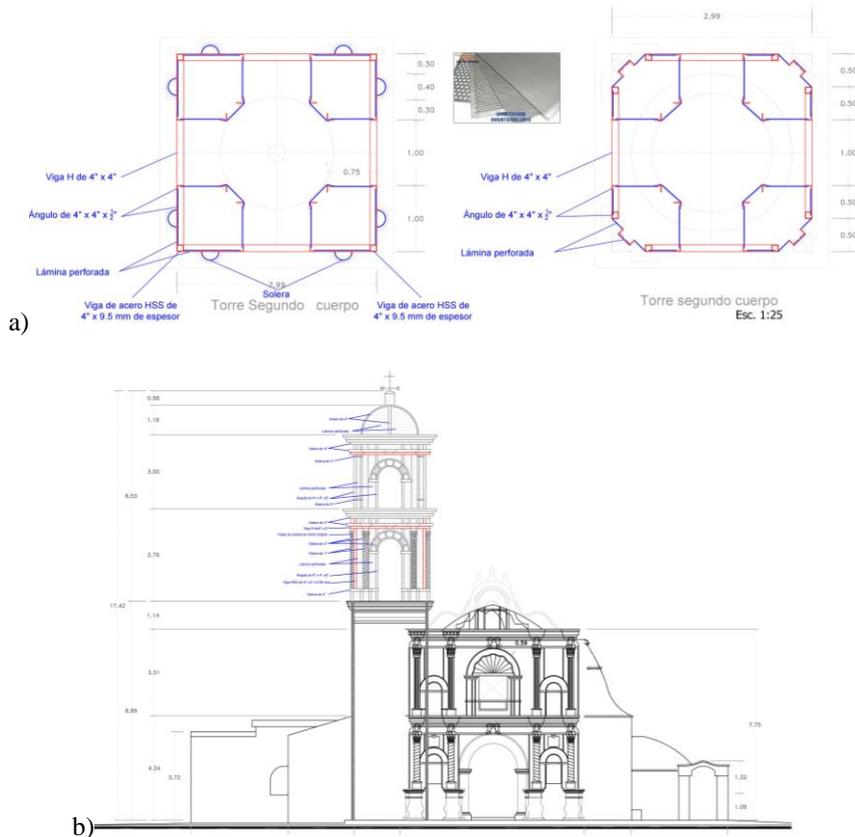
Other proposal was to rebuild the belfry with perforated steel plates (fig. 8). In this solution, there is mechanical incompatibility between the steel elements and stone masonry, as well as difficulty of guaranteeing a good anchoring of the metallic elements. High possibility of failure

of the masonry can occur in the part where the reinforcement ends, due to a local concentrations of stresses in this region. There is a loss of the cultural, artistic and historical values of the church.

**Figure 8:** Reconstruction of the belfry with perforated steel plates: a) plan view; b) frontal view

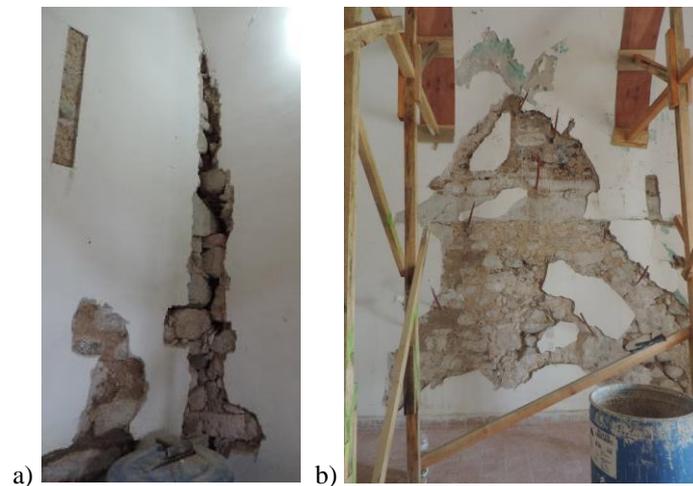
Another example is the intervention in a cloister of a convent. The cloister is a rectangular two-level floor, attached to the west side of the temple. The vaults of the corridors showed longitudinal cracks. Additionally, significant cracking occurred on the walls (fig. 9a), mainly because the masonry have a poor quality. Rounded stones (pebbles) joined with a lime – sand – soil mortar compose the masonry. These type of stones offer a very low bond with the mortar.

The consolidation of the cracks were realized by injection and the cusci-scusci technique was used (fig. 9b). Similar stones (pebbles) and mortar (lime-sand-soil) was used. Thus, the structural capacity was not upgrade. Furthermore, only the visible cracks due to earthquake damage were repaired. The intervention only aimed to return the structure to its original state regardless of the quality of the material, without improve the structural behavior of the building.

**Figure 9:** Damage on walls of a cloister: a) cracks; b) consolidation of the cracks
