## CYCLIC BEHAVIOUR OF BEAM-COLUMN DOWEL CONNECTION IN PRECAST ELEMENTS

**Key words:** Cyclic loading, seismic behaviour, precast reinforced concrete elements, dowel connection, experimental evaluation.

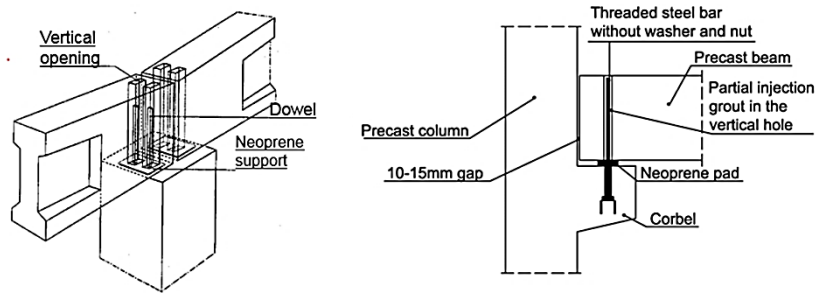
**Figure 1:** Beam to column connection example

Although there are many possibilities and solutions in the precast industry, one of the most common systems used for warehouses and industrial halls is the “Portal frame system”. The columns are usually clamped in moment resisting foundations and the beams are simply supported on the top of the columns, forming together the skeleton of the building. Some of the most problematic elements for these types of structures are beam-to-column connections. In non-seismic practice these connections are designed considering only gravitational loads, lateral loads from wind, and assembling loads<sup>[3]</sup>. However, in seismic areas, the same design considerations do not fully apply and yet the same connections are very often used in practice. In recent years, researchers have started to study in depth the behaviour of beam-to-column connections in seismic areas. Despite the recent concern regarding this topic, the information available is still relatively scarce. This is mainly because precast structures have a multitude of solutions, the major differences being in the case of connections, and information for the behaviour of each individual system during an earthquake event is incomplete and, in some cases, even missing. There are many variations of hinged connections worldwide, but the vast majority use one or two parallel steel dowels that are placed in the direction normal to the plane of the frame. In Europe for example, it is common to use two steel dowels that are anchored in the column and extend through grouted tubes inside the beam<sup>[2]</sup>. One example for this type of connections can be seen in Figure 1. Recent earthquakes from the Italian region of Emilia have provided researchers with in-depth information about the behaviour of reinforced concrete precast industrial buildings. It should be noted that the large majority of the buildings were designed without any concern towards seismic design<sup>[4]</sup>. Some of the buildings that were observed in the area had columns that featured some lateral restraint for the beams in the form of upper pockets (forks) at the top part of the column. These forks were not designed to withstand horizontal actions and they had minimum steel reinforcements; despite this they played an important role in restraining the end rotation of the beam, preventing a possible total collapse.

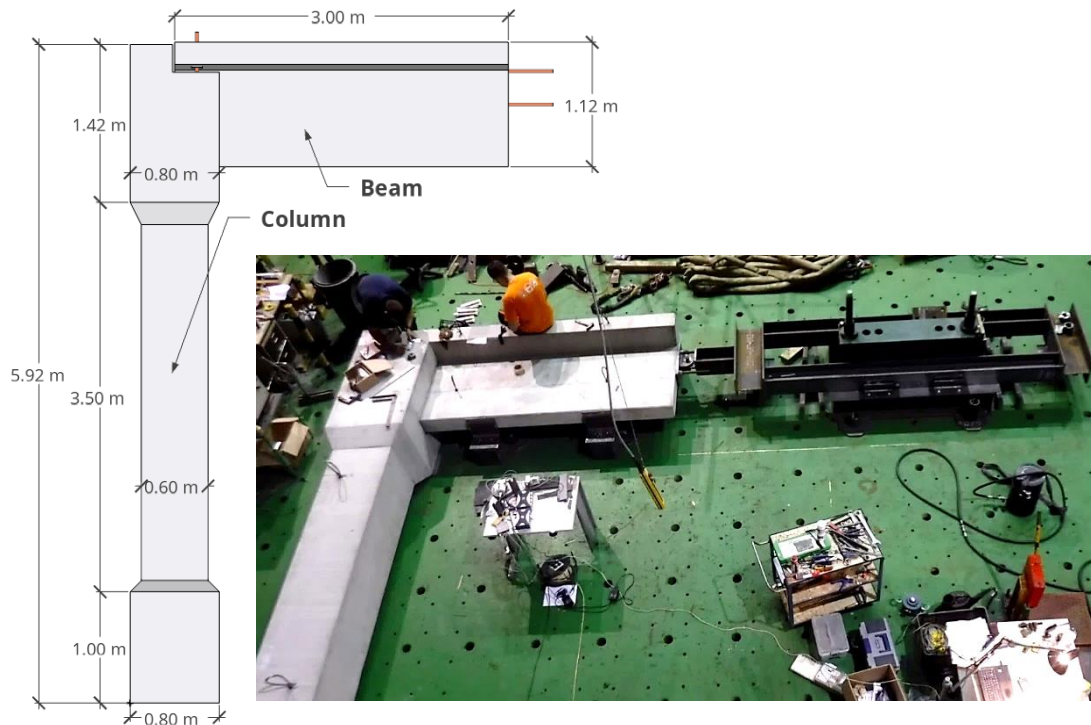
**Figure 2:** Specimens dimensions

Reducing the size of the elements affects the concrete cover for the dowel connection and the results are greatly influenced. In order to avoid this phenomenon, the test specimens cross-sections at the joint had dimensions similar to those used in real-life structures. The beam length was approximately 3m and it was chosen based on the laboratory limitations and also to avoid any local effect on our connection due to the application of the load at the other end of the beam. Prestress concrete beams can have lengths of over 20m. The dimensions of the specimens can be seen in Figure 2.

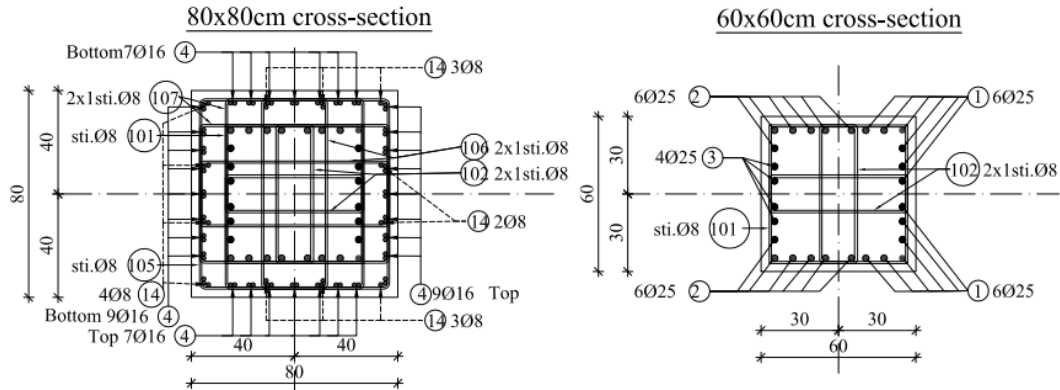
Figure 3: Column cross-section and reinforcement details

The column 60x60cm cross-section was reinforced with longitudinal bars of 25mm diameter. For the stirrups 8mm diameter bars were positioned at a distance of 100mm over the length of the column. The cross-sections at the bottom of the columns were 80x80cm, with additional reinforcement bars, in order to increase the stiffness of the column in that region; this replicates the effect of the column being clamped at the base in a moment resisting foundation. If failure or development of a plastic hinge occurs in the column this will be driven in the area where the cross-section change happens. The cross-section of the column fork was also 80x80cm. Height of the beam was 112cm and width of the flange 64cm. At the end of the beam not connected with the column two steel bars were included for fitting the steel assembly that will transmit the load to our specimens. Additional details regarding the

reinforcement placement is provided in Figure 3 for the column. The dimensions of the elements and the reinforcement percentages were chosen according to real-life design cases and existing structures.

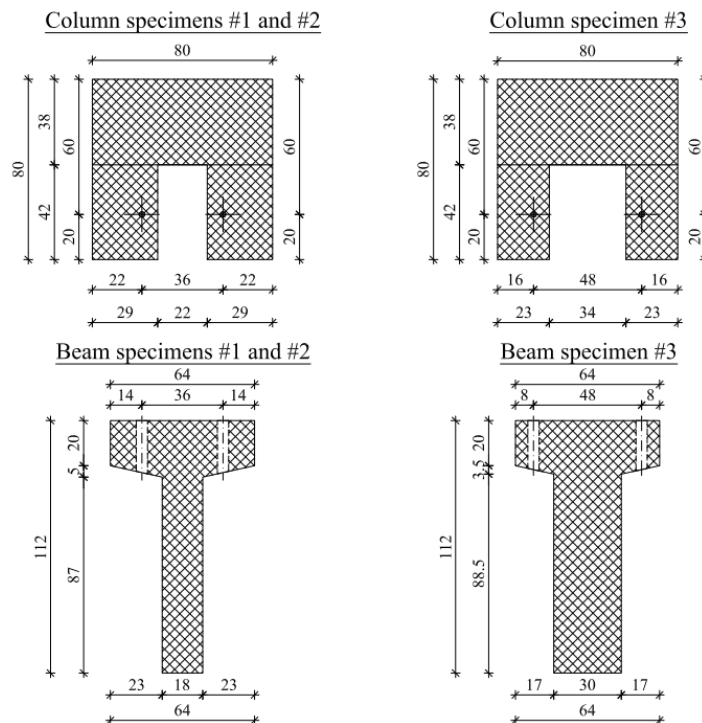
Figure 4: Column and beam cross-sections - differences between specimens #1, #2 and #3

Three sets of specimens were casted for this experimental campaign. The first two sets, #1 and #2, corresponding to the monotonic test and first cyclic test, respectively, were identical in terms of concrete specimen's dimensions. One notable difference is the dowel diameter: 27mm for specimens #1, and 32mm for specimens #2. For set #3 the dowel diameter is 32mm, but the thickness of the column fork sides was reduced, and the thickness of the beam web was increased accordingly. The modification of set #3 was intended to reduce the concrete coverage of the dowels, as it is shown in Figure 4.

In this test, the beam web was larger, with a width increase from 18 cm to 30 cm. This also reduces the thickness of the fork sides in the column. In this situation, the steel dowels and the sleeves inside the beam are also shifted, outwards, to the sides of the elements, resulting in a substantial reduction of concrete cover around these connection elements.

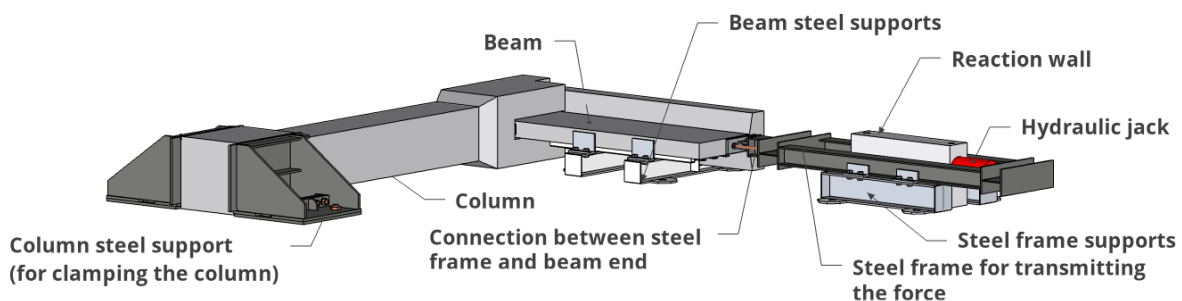
**Figure 5:** Test setup description – Perspective view

As it was previously stated, because of the large weight of the tested specimens and safety issues, all the tests were performed horizontally. Sets of greased steel plates were positioned under all the moving elements to reduce friction as much as possible. The column was clamped at the base using steel assemblies that replicate a real-life pocket foundation. The force was applied at the end of the beam by using another steel assembly which permitted the installation of the hydraulic jack, from one side to another, to perform the cyclic analysis.

Steel supports for the beam and the force transmitting frame maintained the direction when applying the load. All the steel assemblies were custom made for these tests. The details of the test setup can be seen in Figure 5 and Figure 6. All the steel assemblies were fixed in the strong floor of the laboratory.

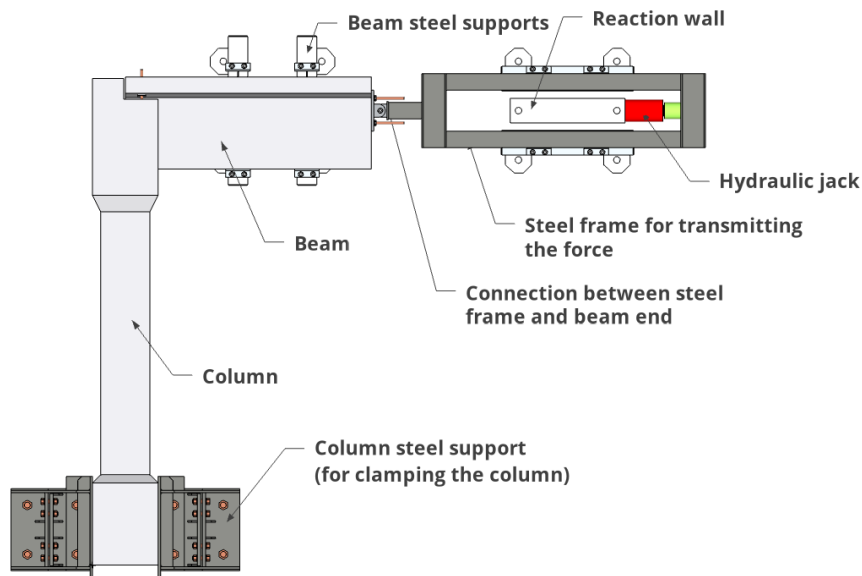
**Figure 6:** Test setup description – Top view

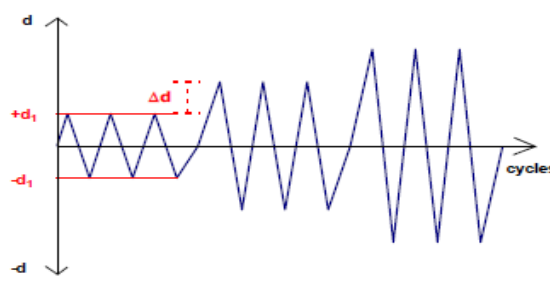
**Figure 7:** Loading history of the cyclic test<sup>[6]</sup>

Loading was performed based on the description offered in the Safecast<sup>[6]</sup> testing protocol. The maximum displacement (at failure) was obtained from an initial monotonic test. The experimental cyclic response was obtained by applying the load history described in Figure 7, meaning groups of three cycles of the same amplitude are performed step by step with subsequent increments  $\Delta d$  up to the ultimate or test limit.

For the cyclic test the load displacement increments were chosen based on the initial monotonic test, the maximum displacement from the first test was divided into three increment groups: 60mm, 120mm and 180mm (see Figure 7).

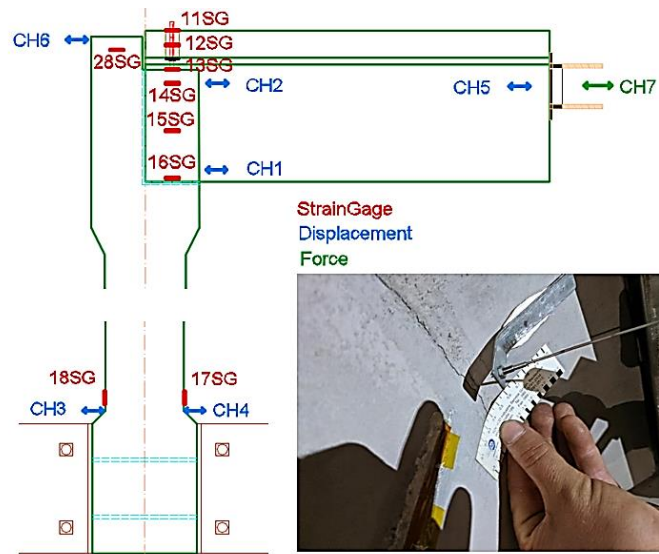
Figure 8: Positions for the measuring equipment

During the experiments, the lateral force was continuously measured to obtain the force-displacement diagrams. In addition, displacements transducers and strains gauges were installed in critical points (Figure 8). This information is essential for calibrating later, the finite element numerical models. After each cycle, the crack openings on the surface of the column and beam elements were measured.

For the first set of specimens (#1), a monotonic test was performed. This was done by pulling the end of the beam, this being the most unfavourable situation for this connection. The whole bearing capacity is given by the shear capacity of the two dowels combined with a low concrete coverage for the connectors. In compression, the concrete covers are larger. On top of the shear strength of the dowel, there is an additional tension strength in these elements due to the dowel catenary effect. For test specimens #2 and #3 the load increments were determined based on the maximum displacement obtained at failure from the monotonic test. This displacement was divided into three equal increments. The force-displacement graphs have been plotted using the measurements from CH7 for the force and CH6 for the displacement (Figure 8).

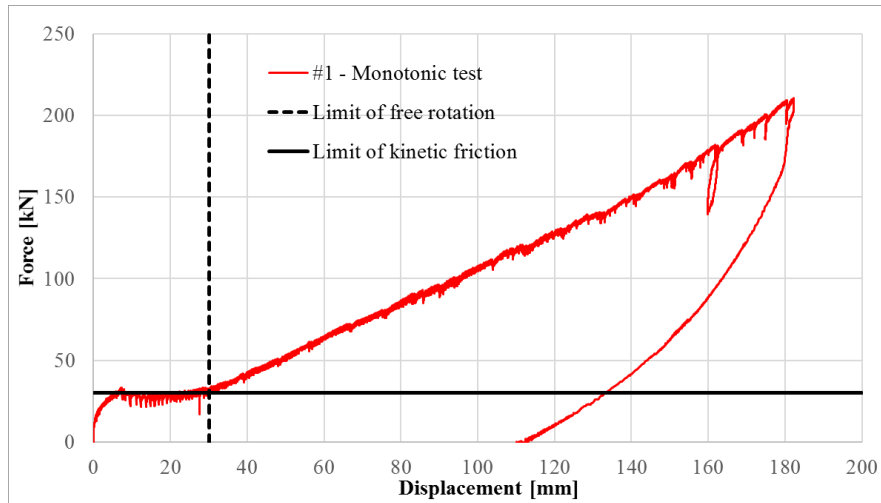
**Figure 9:** Specimens #1 – Force-Displacement graph

This first test was force controlled with a  $\Delta d = 10\text{kN}$  increment at each step until failure. After each step, the cracks and the connection were checked. Failure was reached at approximately 208kN with a maximum displacement of 182mm (Figure 9). It should be noted that the displacement is much larger than expected because the column base support allowed for some rotation and the column was not completely fixed. This rotation will be calculated and extracted later for obtaining the absolute displacement. Because of the configuration of the testing setup, it is nearly impossible to completely eliminate the friction between the structural concrete elements and the supports. Friction force was shown to be at around 30kN. Kinetic friction was constant over the test duration.

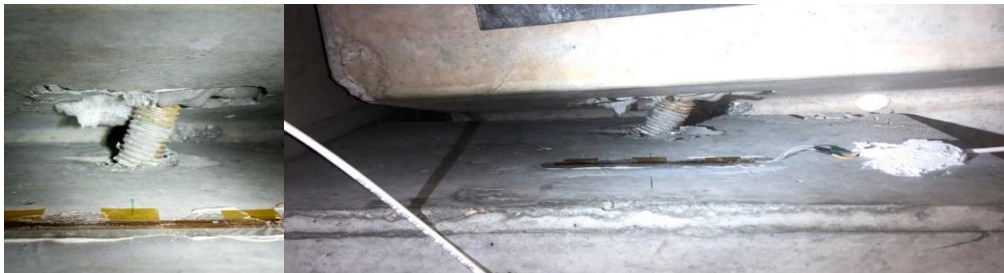
**Figure 10:** Specimens #1 – Failure by dowel yielding

Above the 120kN point, the steel dowel started deforming. Yielding of the bar was reached at the force of 208.7kN which coincides with the failure point of the connection. There was also some small crushing of the concrete around the dowel (Figure 10). Most probably this would have increased but the test was stopped due to safety reasons and to avoid any damage to the equipment.

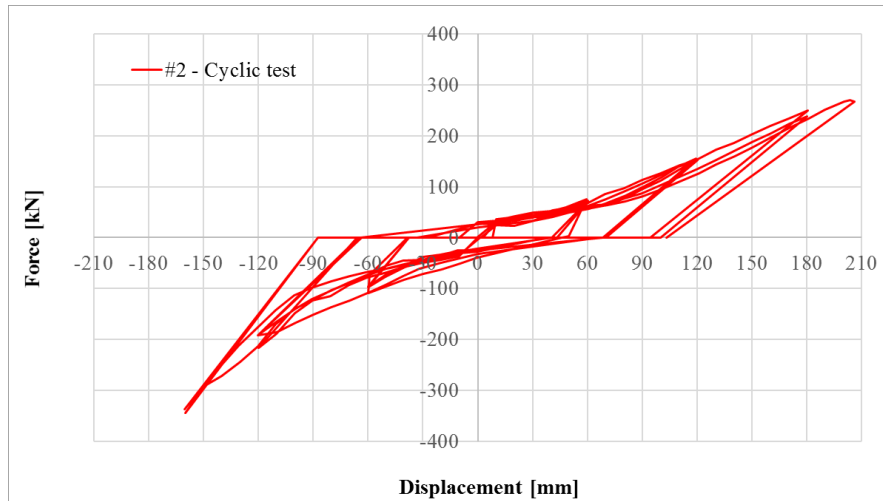
**Figure 11:** Specimens #2 – Force-Displacement graph

Failure point was reached in tension for a force value of 270kN with a maximum displacement of approximately 207mm (Figure 11). It should be taken into consideration that the concrete used in these tests was high strength (around 70MPa compressive strength). In

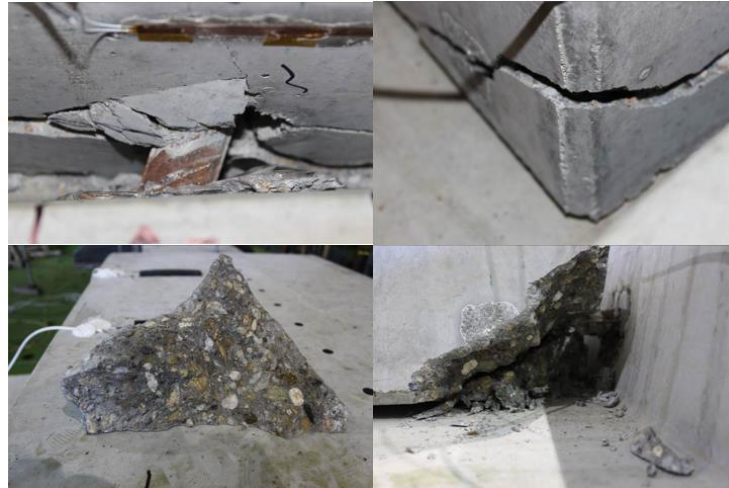
**Figure 12:** Specimens #2 – Failure by dowel yielding and concrete spalling

Failure was a combination of steel dowel yielding and concrete spalling in the column fork, around the dowel (Figure 12). Concrete coverage of the dowel is insufficient for this particular connection. For this situation, the maximum crack width was slightly larger, 0.60mm, and in the same position as for the first test (base of the column in the area of cross-section change). This indicates that there is no significant damage to the column and the failure of the assembly was strictly related to the failure of the connection.

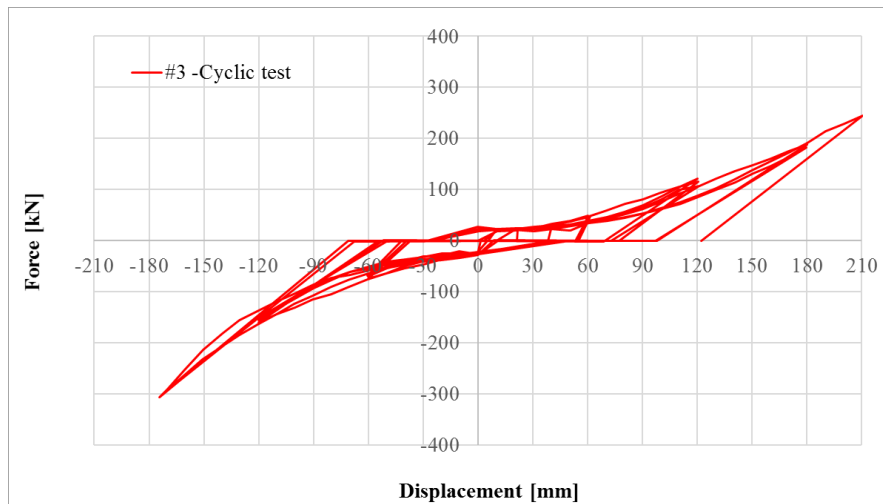
**Figure 13:** Specimens #3 – Force-Displacement graph

Failure was reached in tension at 245kN with a maximum displacement of 210mm (Figure 13). The failure mechanism was again a combination of the steel dowel yielding and concrete spalling (Figure 14). The smaller concrete cover for the dowels influences the capacity of this connection resulting in a smaller failure load compared to the previous cyclic test. The difference in maximum load can be seen also in the case of the maximum crack width at the base of the column, in the area of cross-section change. For this case the value was 0.50mm compared to 0.60mm for test specimens #2. At the final step there was a large relative displacement between the column and the beam. The relative horizontal displacement between the beam and the column was approximately 6cm at failure.

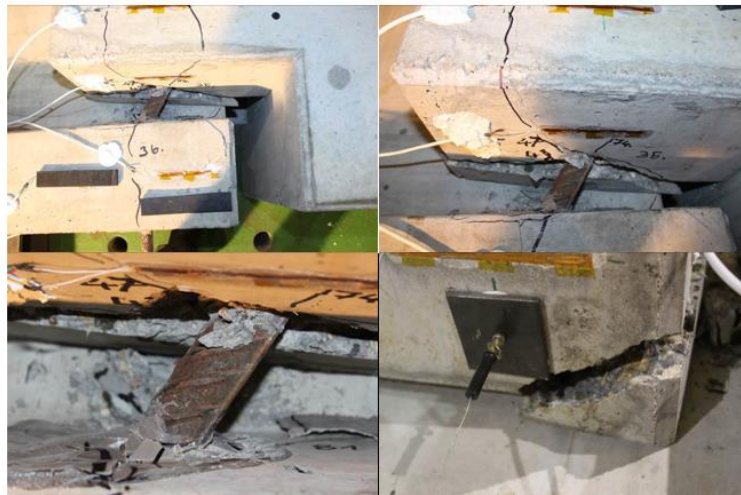
**Figure 14:** Specimens #3 – Failure by dowel yielding and concrete spalling
