# INADEQUATE CASES OF INTERVENTION IN ARCHITECTURAL HERITAGE BUILDINGS IN MEXICO AFTER THE SEPTEMBER 2017 EARTHQUAKES

FERNANDO PEÑA<sup>1\*</sup> AND MARCOS M. CHÁVEZ<sup>1</sup>

<sup>1</sup>Instituto de Ingeniería  
Universidad Nacional Autónoma de México  
Ciudad Universitaria, 04510 Mexico City, Mexico  
e-mail: [fpem@pumas.iingen.unam.mx](mailto:fpem@pumas.iingen.unam.mx), [mchavezc@iingen.unam.mx](mailto:mchavezc@iingen.unam.mx), [www.iingen.unam.mx](http://www.iingen.unam.mx)

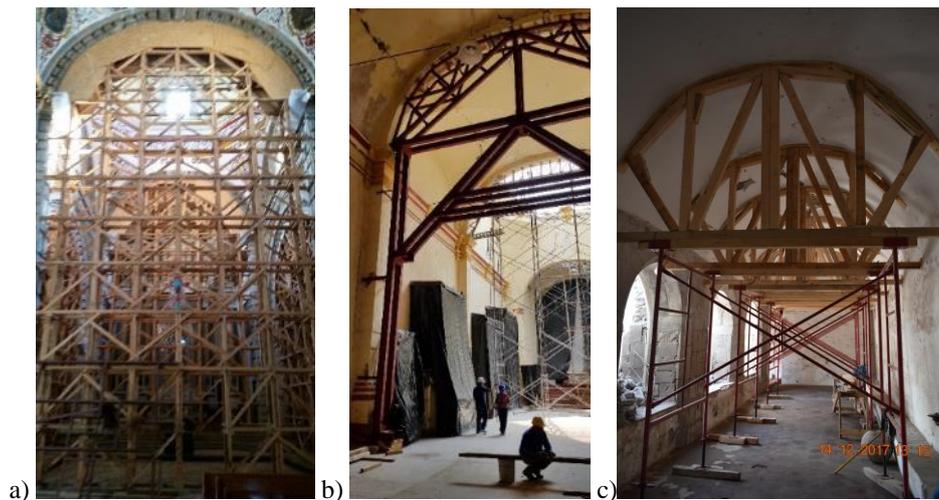
The shoring system is a temporary system that must be removed when the intervention works are finished. Wood is the most common material used for shoring system due its versatility, manageability, ease of construction and cheap. However, good quality wood must be used; as well as particular attention to the connections must be paid. The quality of the wood is with regard to: material (use of structural wood), element (no slender elements or buckling elements) and structural system (strength capacity). In the case of wooden elements, the most common practice is to build a wooden truss support (figure 4a). In other cases, especially when the height of building is considerable, as in churches, a steel shoring system (fig. 4b) or mixed system of steel and wood are used (fig. 4c).

**Figure 4:** Examples of shoring systems: a) wood; b) steel; c) mixed
